INVESTIGATION OF SOLID CADMIUM EMBRITTLE-  
MENT IN A-7 AIRCRAFT FAILED SHAFTS AND  
HORN FRACTURE SURFACES

Vought Aeronautics Company

AFML-TR-72-249

January 1973

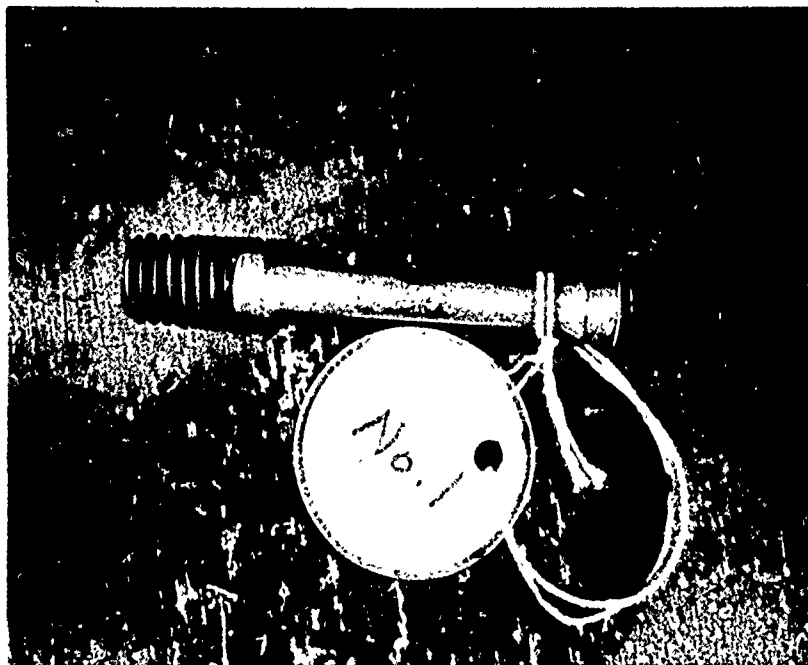
Figures 6 and 7 show one of the round tensile specimens after exposure. Note the deformation of the cadmium plate where the pressure plate contacted the specimen.

Figure 6. Embrittlement Test Specimen after Exposure for 20 Hours

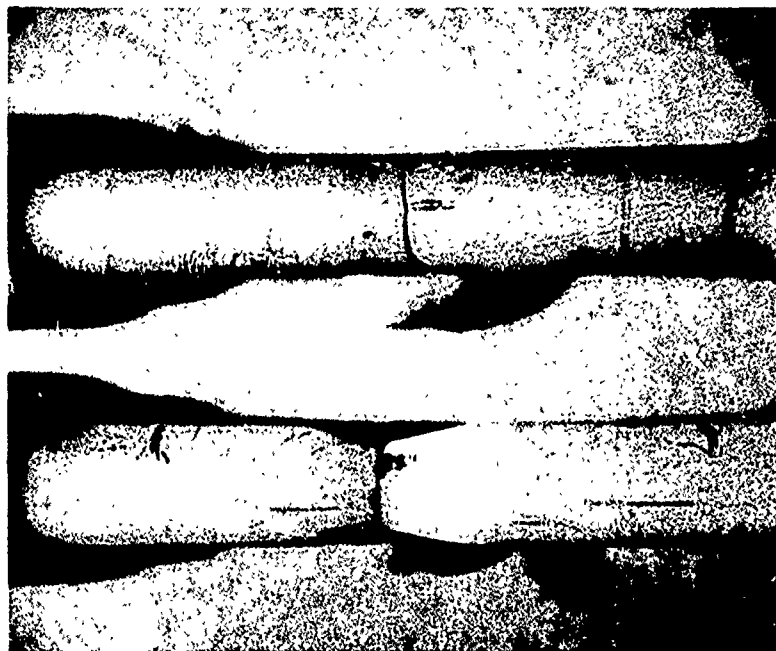
The embrittled samples generally showed little or no elongation and reduction of area when failed statically. The contrast between embrittled and non-embrittled specimens is shown in Figure 8. Note the necking down of the control sample, while the embrittled samples shows no necking.

Figure 8. Comparison of Embrittled (Upper) Vs. Control (Lower) Specimens Showing Variation in Ductility at Fracture

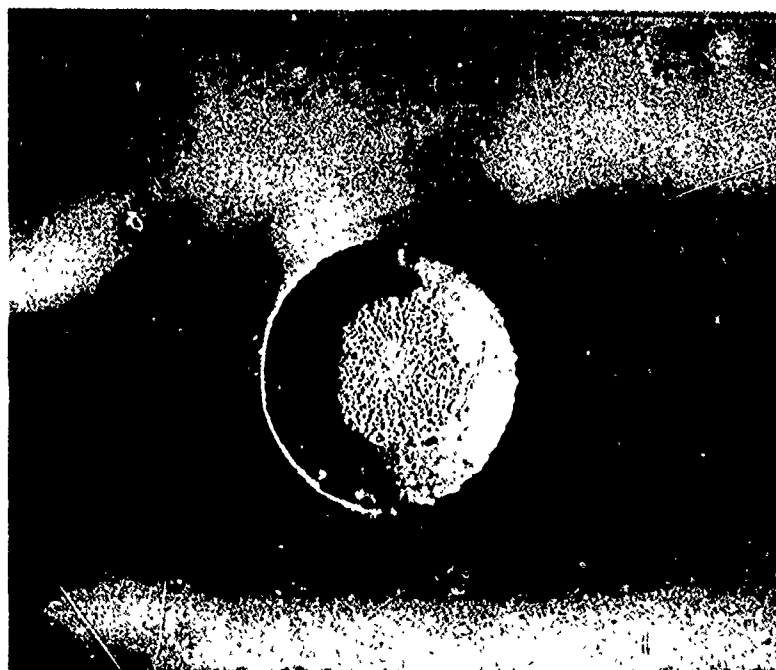
The fracture surfaces of the tensile specimens are shown in Figures 9 through 13. The control sample, Figure 9, consisted of a normal cup and cone fracture. Cracking first began at the center of the specimen and propagated radially. Figures 10 and 11 show low embrittlement cadmium samples. Cracking originated from the side of the specimens at one of several crescent

Figure 9. Fracture Surface on a Control Specimen Consisting of Normal Cup and Cone Fracture

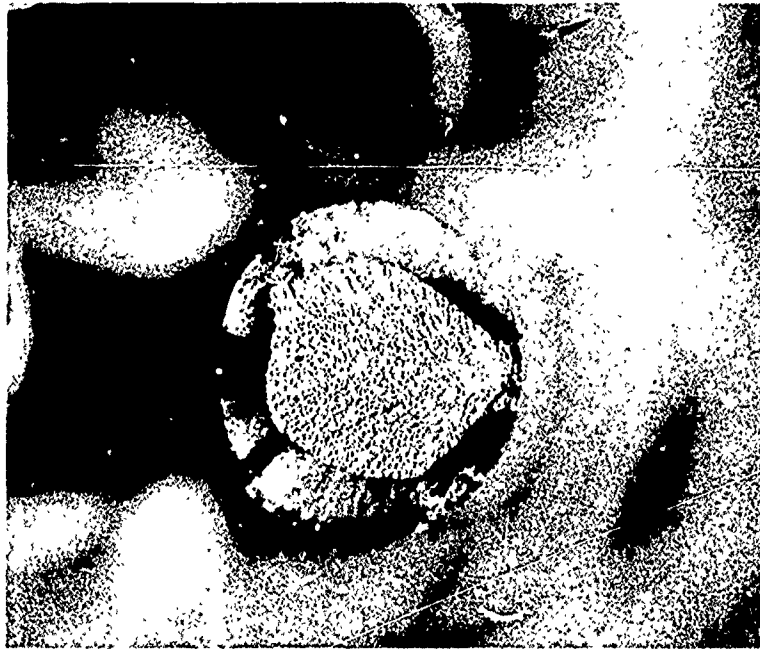
Figure 12. Fracture Surface of Vac-Cad Specimen No. 1.

shaped regions on either sample. The crescents were characterized by a crystalline appearance and had a distinct yellow-gold coloration. Several secondary origins were observed on each fracture although the tensile fracture had propagated from a single origin. The vacuum cadmium specimens are shown in Figures 12 and 13. Unlike the low embrittlement cadmium samples, the vacuum cadmium specimens exhibited only one origin on each specimen. Thus it would appear that the low embrittlement cadmium plate was more prone to induce embrittlement than the vacuum cadmium plate. Other variations which were apparent were that the origins on the vacuum cadmium specimens were irregularly shaped and more darkly colored as compared to the low embrittlement cadmium specimens. In all cases however, the origin cracks were located only where the pressure had been applied.

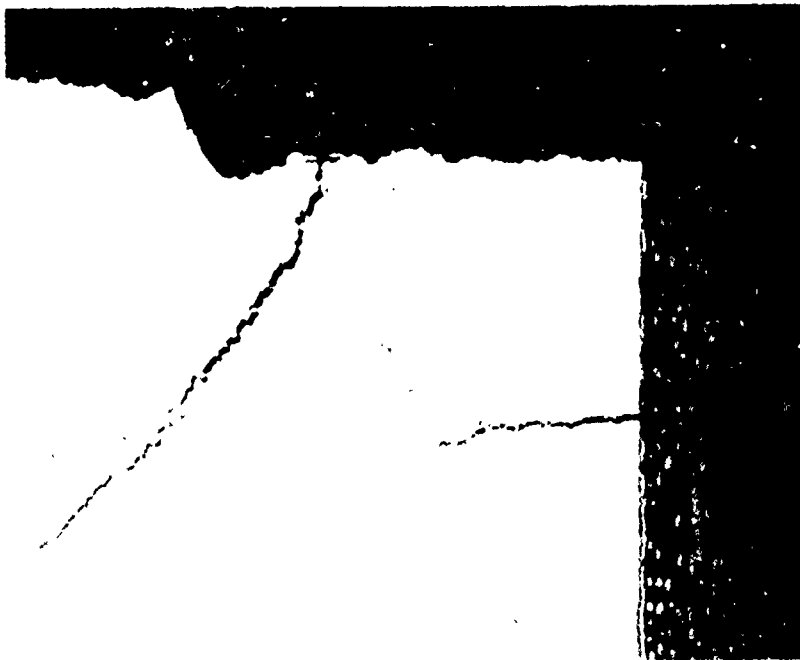
The photomicrographs in Figures 14 through 19 characterize the conditions found in the cadmium-induced failures. Cracks in the low embrittlement cadmium plated specimens were more predominant and severe than in the vacuum deposited cadmium. However, numerous surface initiated cracks were observed in both deposits. These cracks were predominantly intergranular with possible transgranular cleavage depicted as a step pattern in the crack networks. The origins in the low embrittlement cadmium plated specimens generally followed a single plane while the vacuum cadmium tended to branch into several crack fronts. The cross section in Figure 15 shows a cadmium plated surface with a cadmium deposit in the crack. The cadmium was believed to be smeared into the crack during the sectioning and polishing operation. To substantiate this deduction, the metallographic specimen was lightly etched with nital. This resulted in complete removal of the surface smeared cadmium in the cracks while leaving the plated surface only slightly etched and intact. Also electron microprobe analysis of the fracture surfaces revealed no heavy deposits of cadmium such as revealed in the photomicrograph. This aspect will be discussed later.

Figure 14. Photomicrograph of Cross Section of Ti-CD Induced Failure Exhibiting Cracks Perpendicular and Parallel to Fracture Origin at Top-right. Unetched

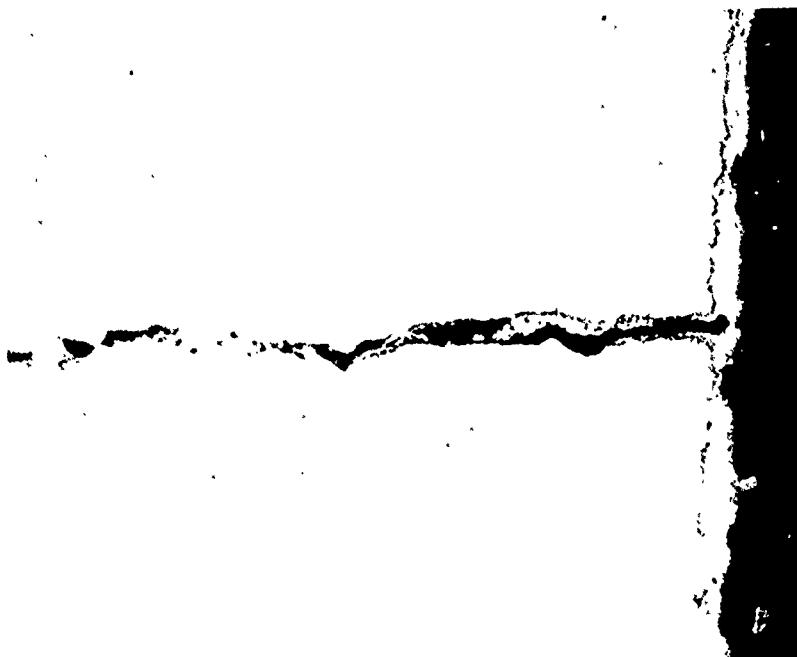
Figure 15. Parallel Crack Depicted in Figure 12 Showing Ti-CD Plate at Surface and Smeared into the Crack

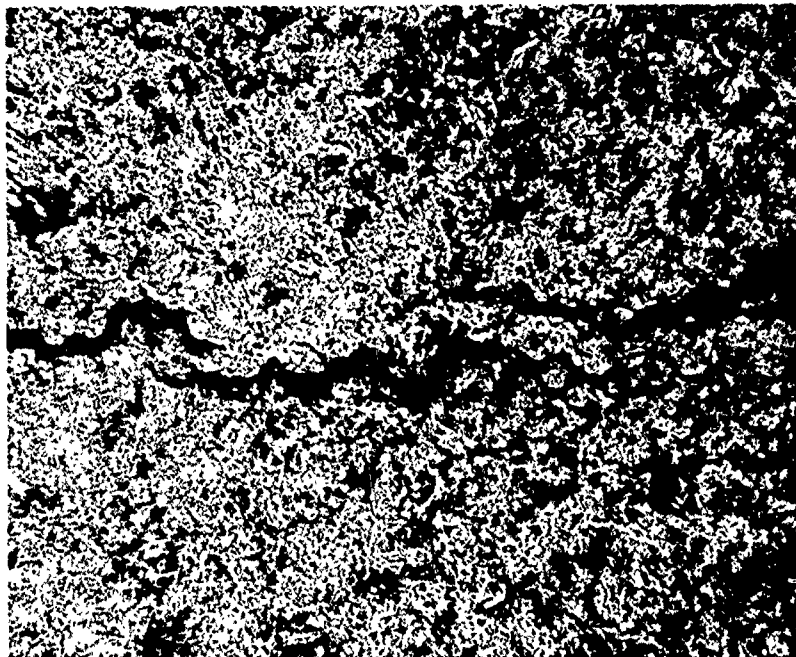
Figure 16. Perpendicular Crack Depicted in Figure 14 Showing Predominantly Intragranular Mode with Possible Cleavage.

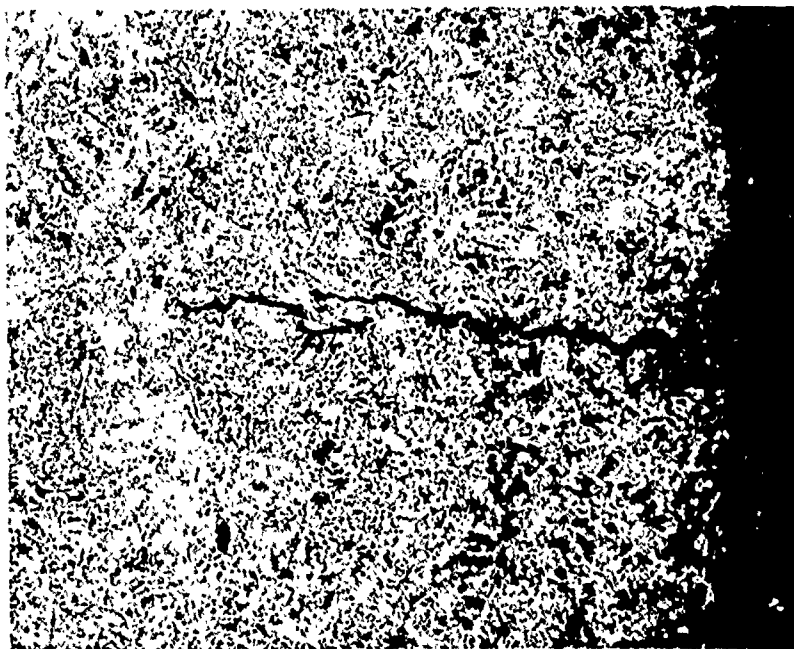
Figure 17. Additional Crack Parallel to Origin in Figure 14. Crack Initiated at the CD-Steel Interface and Appeared to be Both Intergranular and Cleavage Modes.

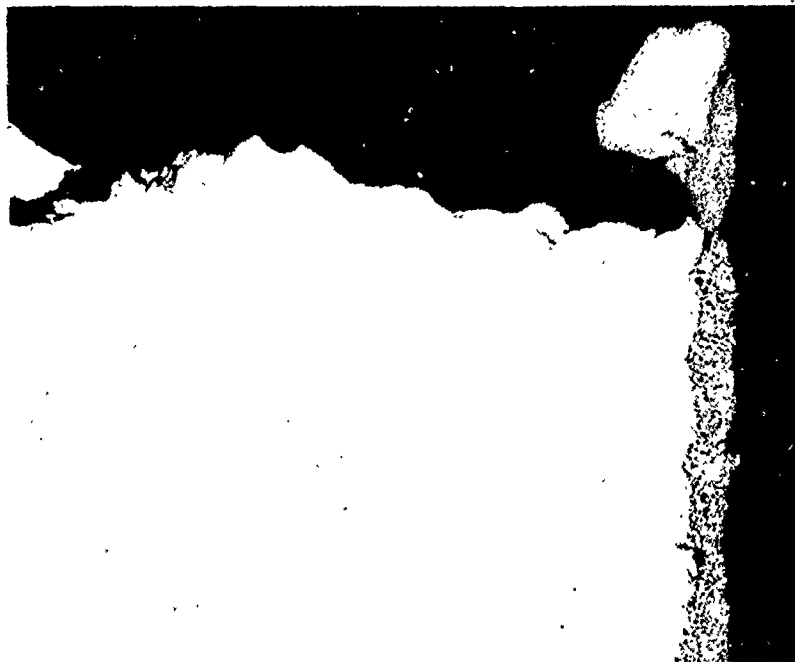
Figure 18. Cross Section of Vac-Cad Induced Failure Showing Origin at Top Right and Some Intragranular Cracking at the Fracture Surface. Unetched.

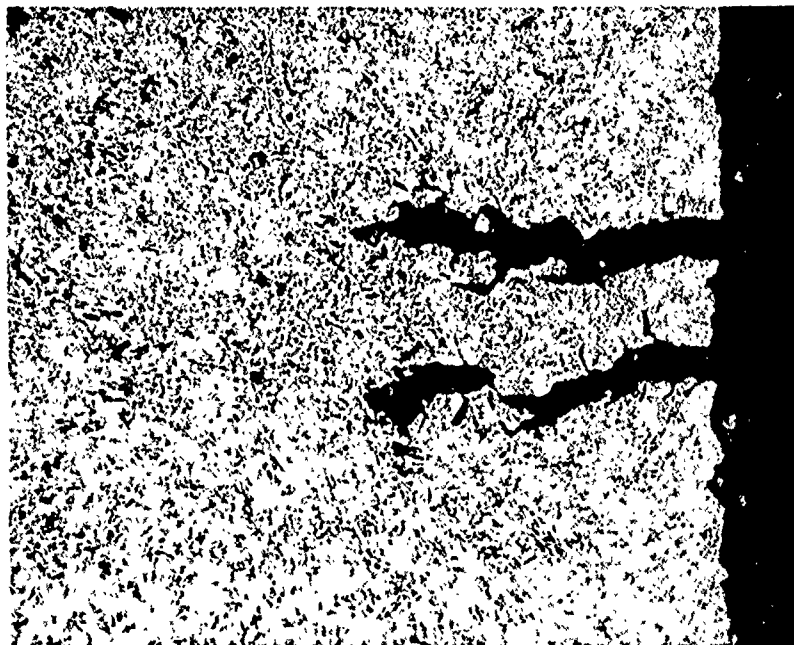
Figure 19. Parallel Cracks Adjacent to Origin in Figure 18. Intergranular Branching Can Be Seen Propagating from Cracks Opened Up During Tensile Loading. Nital Etch.

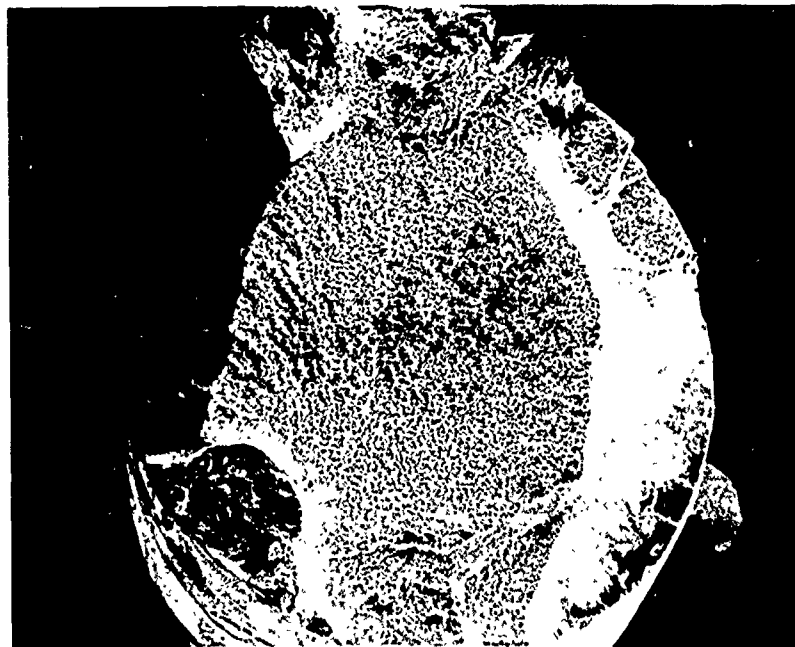
Electron microscopy revealed several features not apparent at lower magnifications. Figures 20 and 21 show one of the low embrittlement cadmium fractures in detail. Figures 22 and 23 are comparable pictures of a vacuum cadmium sample. In the lower magnification shots, 20 and 22, it is apparent that cracking originated at the steel-cadmium interface and progressed into the steel. The higher magnifications, Figures 21 and 23, show that the origins are somewhat different. The low embrittlement cadmium appears to have generally followed a single plane; the vacuum cadmium, however, tended to branch into several cracks.

Figure 20. Photomicrograph Showing the Fracture Surface of Ti-Cad Specimen No. 2 - Scanning Electron Micrograph

Figure 21. Photomicrograph Showing Details of One of the Origin Cracks on Ti-Cad Specimen No. 2 - Scanning Electron Micrograph

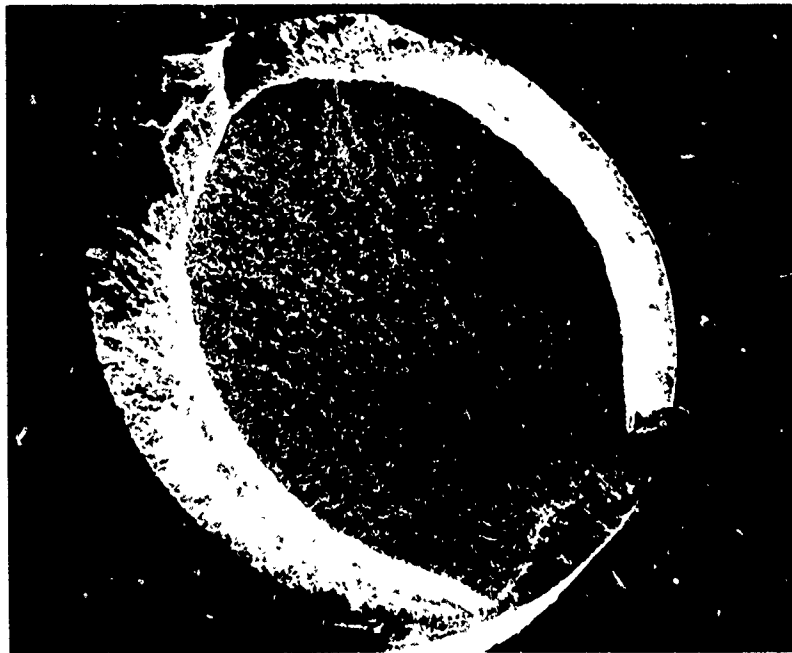
Figure 22. Photomicrograph Showing the Fracture Surface of Vac-Cad Specimen No. 2 - Scanning Electron Micrograph

Figure 23. Photomicrograph Showing the Origin Crack of Vac-Cad Specimen No. 2 - Scanning Electron Micrograph

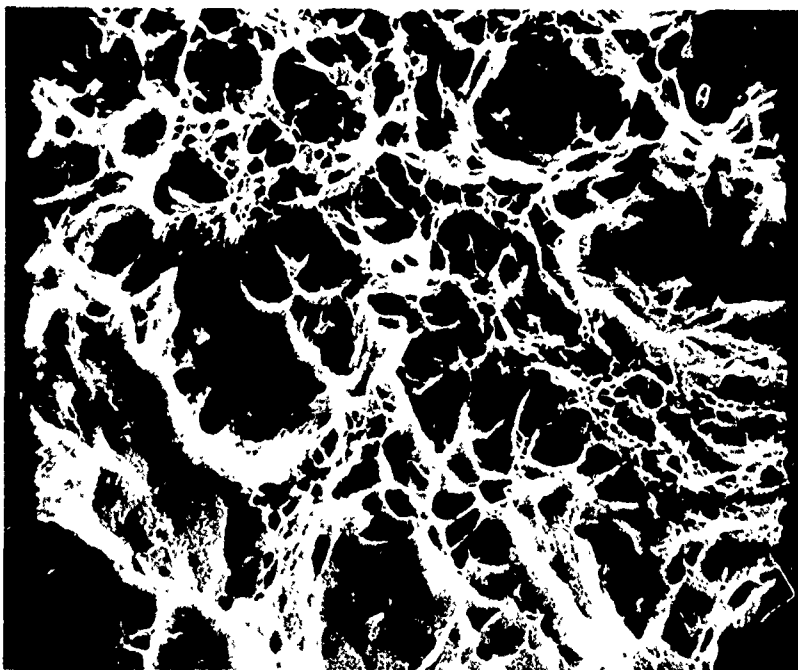
(Figure 24) was comprised completely of cleavage fracture. The vacuum cadmium sample (Figure 25) consisted of a mixture of intergranular and cleavage fractures. Near the middle of the origins, the difference disappeared and the topography became mixed cleavage and intergranular cracking as demonstrated in Figures 26 and 27. The topography remained the same until the onset of catastrophic failure. Figures 28 and 29 show the fracture topography adjacent to the rapid fracture zone. In both cases, the rapid fracture zone was comprised of dimpled rupture as illustrated in Figure 30.

Figure 30. Appearance of the Fracture in the Rapid, Fracture Zone of the Embrittlement Test Specimens, Scanning Electron Micrograph

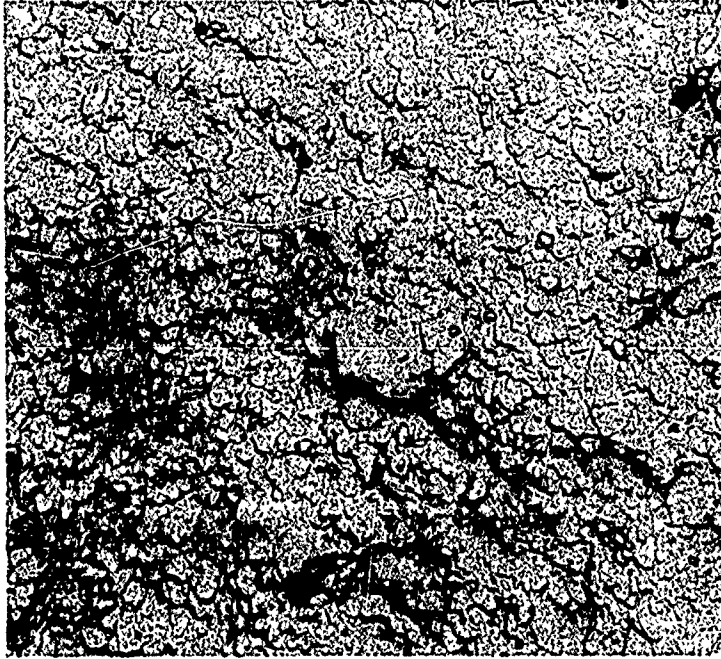
Results obtained using carbon replicas on the transmission electron microscope were the same as those obtained using the scanning electron microscope. Figures 31 through 34 depict the topography observed progressing into the steel from the cadmium-steel interface. The initial mode of propagation was a mixture of intergranular and cleavage cracking (Figures 31 to 33). The fast fracture was dimpled rupture as shown in Figure 34.

Figure 34. Appearance of the Fast Fracture Zone on Ti-Cad Specimen No. 1.  
Transmission Electron Micrograph

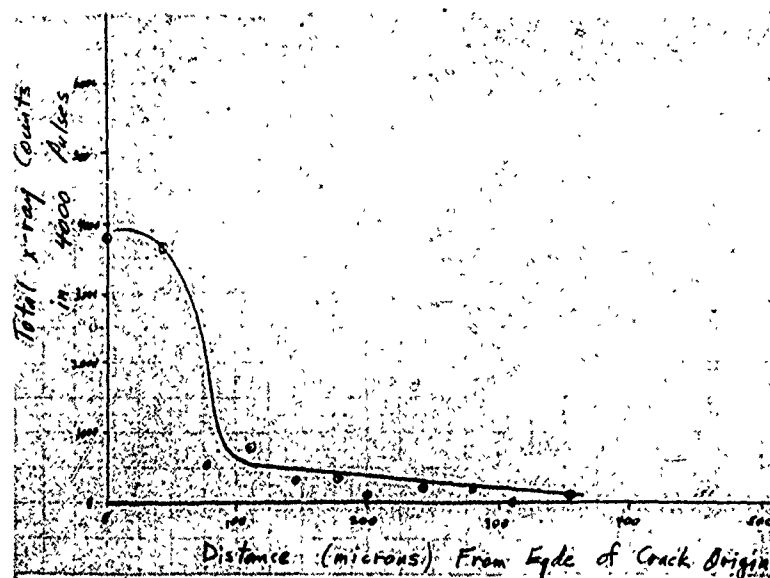
Figure 75 shows the backscattered electron image at the fracture origin. The light-colored areas near the edge appear to be the cadmium plate. This is confirmed by the cadmium distribution map in Figure 76 and the concentration profile, Figure 77.

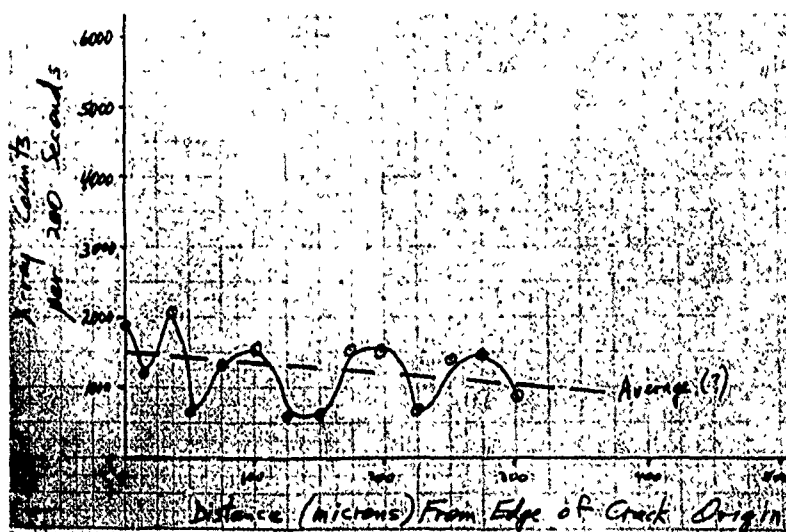
Figure 79 shows the backscattered and secondary electron image of the A7B-121 fracture origin. The cadmium distribution map, shown in Figure 80, indicates scattered pockets of cadmium distributed over the fracture surface. There is no evidence of a concentration gradient, however. Point counts for this area are shown in Figure 81. No gradient is present. The count rate is sporadic, but uniformly low.

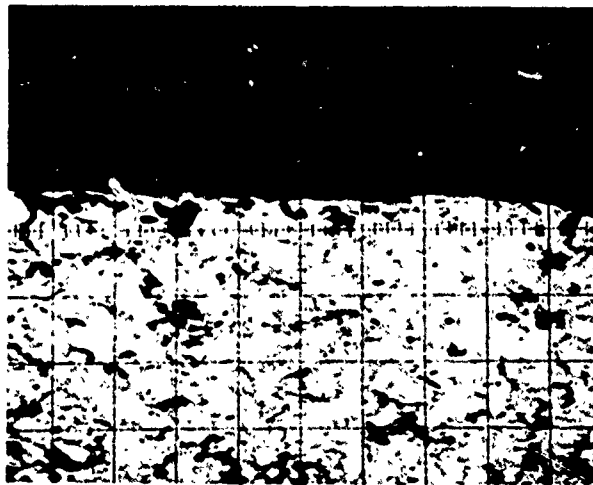
Figure 84. Cadmium Concentration Profile Measured Down the Vertical Batched Center Line Shown in Figure 82. ARL Probe

Figure 84 shows the cadmium profile down the centerline of Figure 82. This again indicates no concentration gradient, in agreement with Figure 83 and the corresponding step scan.

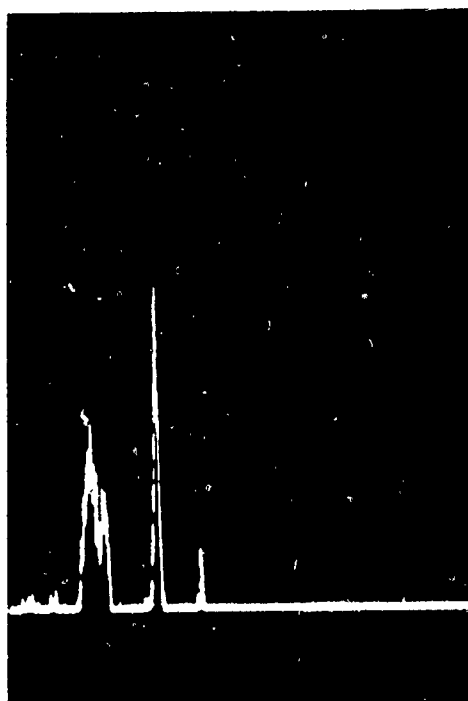
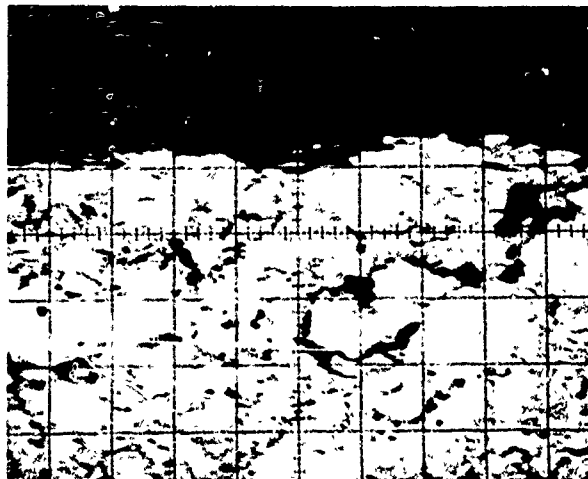
Figures 85, 86, and 87 show, respectively, for this sample the back-scattered electrons, cadmium distribution, and cadmium profile. Again, cadmium is apparent on the plated surface, but no gradient is seen on the fracture surface itself. And again, the step scan analysis indicated no gradient on the fracture surface.

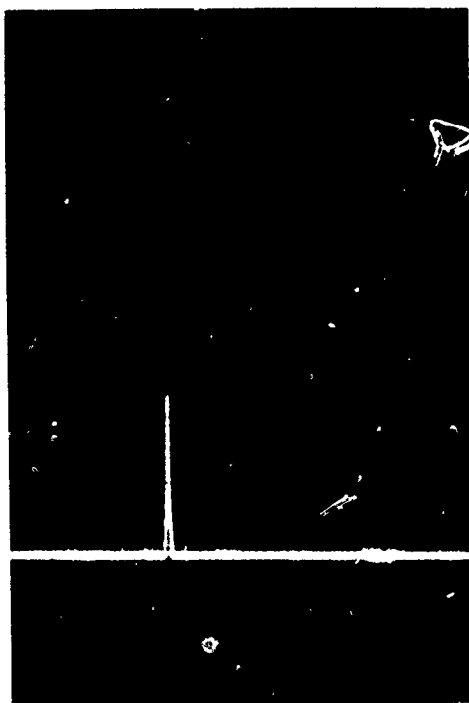
Figures 88, 89, and 90 show backscattered electrons, cadmium distribution, and the cadmium profile. Results are in agreement with those reported for the above sample.

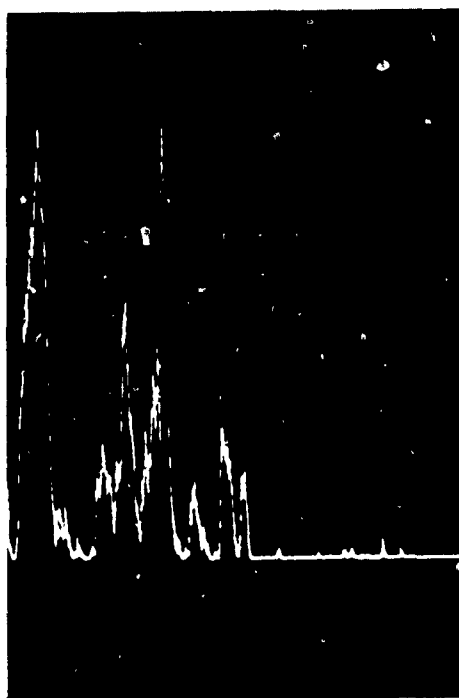
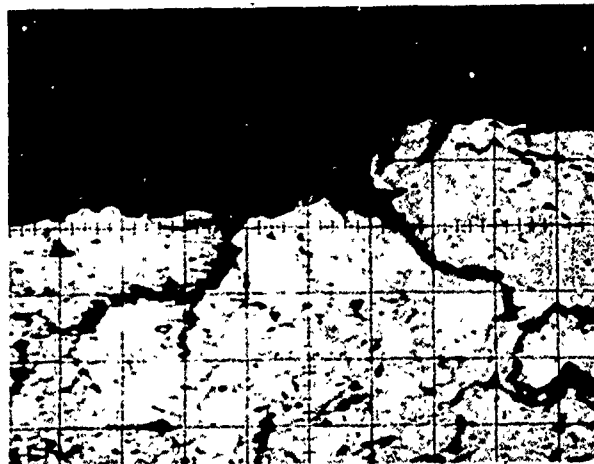
Figures 91, 92, and 93 show similar results for this in-service fracture.

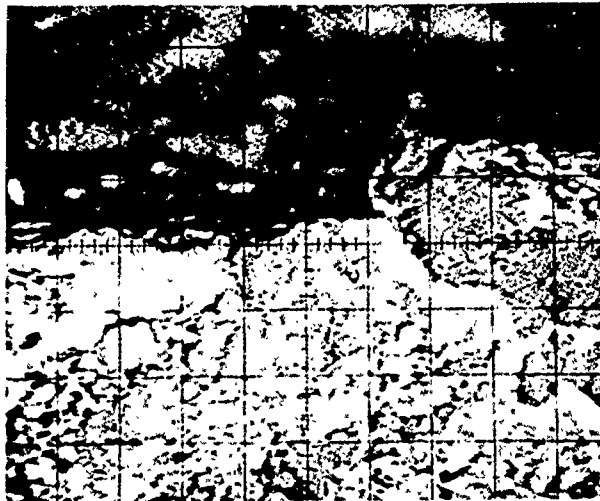
Figure 94 shows the backscattered electron image for the origin of this fracture. For comparative purposes, the secondary electron image is shown in Figure 95 and the specimen current image in Figure 96 for the same surface area. These furnish a good example of the strong points in each of the three types of presentation. The backscattered image emphasizes the system of deep cracks associated with this fracture origin. The secondary image gives a good general picture of surface topology, while the specimen current image hints at elemental segregation on various parts of the surface area under consideration.

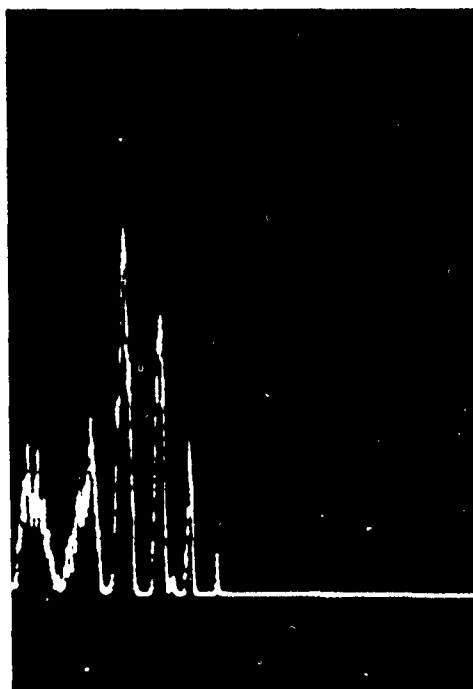
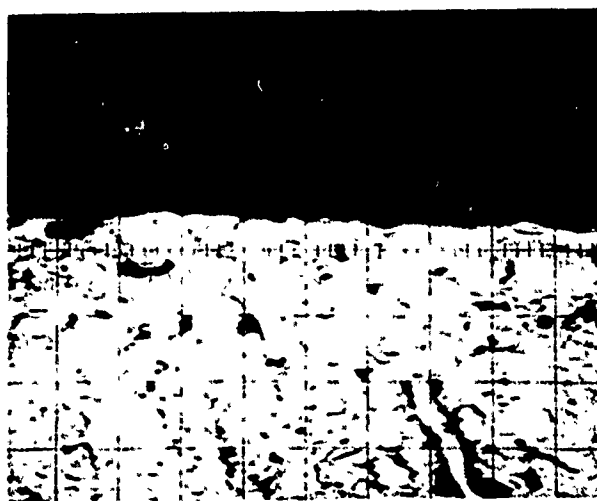
Figures 97 and 98 show cadmium distribution and distribution profile respectively for this specimen. Again, cadmium can be seen on the plated surface at the top of the photo, but no gradient appears on the fracture surface. Again, step scan analysis agreed with the observed lack of a cadmium gradient.

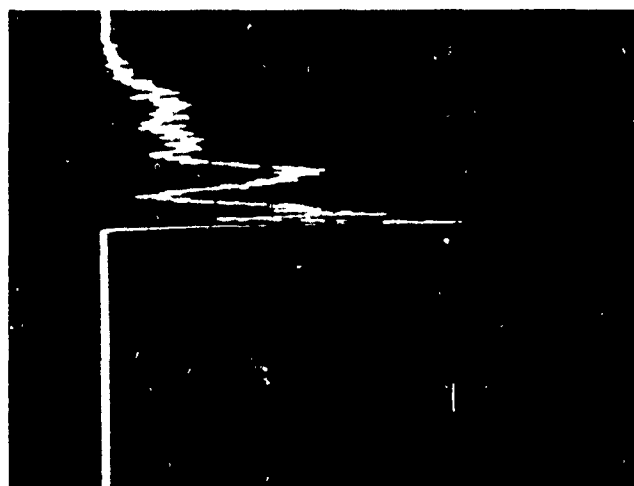
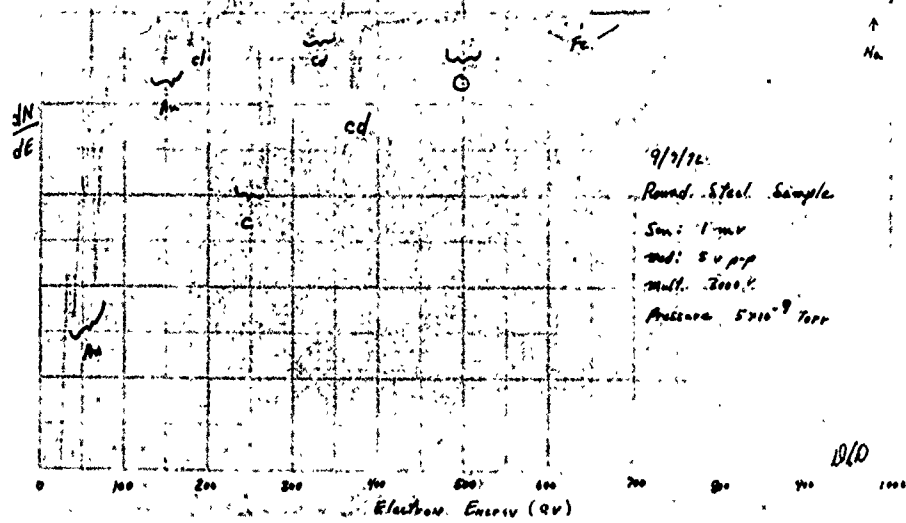
Figure 99 shows the backscattered electron image of the origin of the fractured UHT horn from A7B-183. Corresponding cadmium distribution and profile for this fracture area are shown in Figures 100 and 101. As on the shaft failures, no cadmium gradient was found.

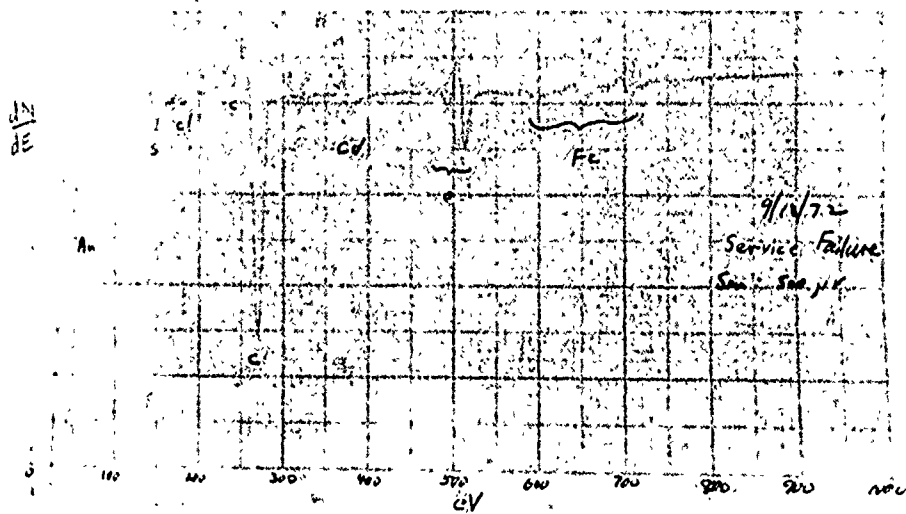
Figure 102. Auger Spectrum of Induced Cadmium-embrittled Fracture.

Figure 102 shows the Auger Electron Spectrum obtained on the induced cadmium-embrittled fracture. Visible on the spectrum are the gold plate, sodium and chlorine from the salt crystal used as mask, carbon (probably
